**JUST LIKE IT USED TO BE**

**Refurbishment of the roof at the Silk Museum in  
Macclesfield, England**

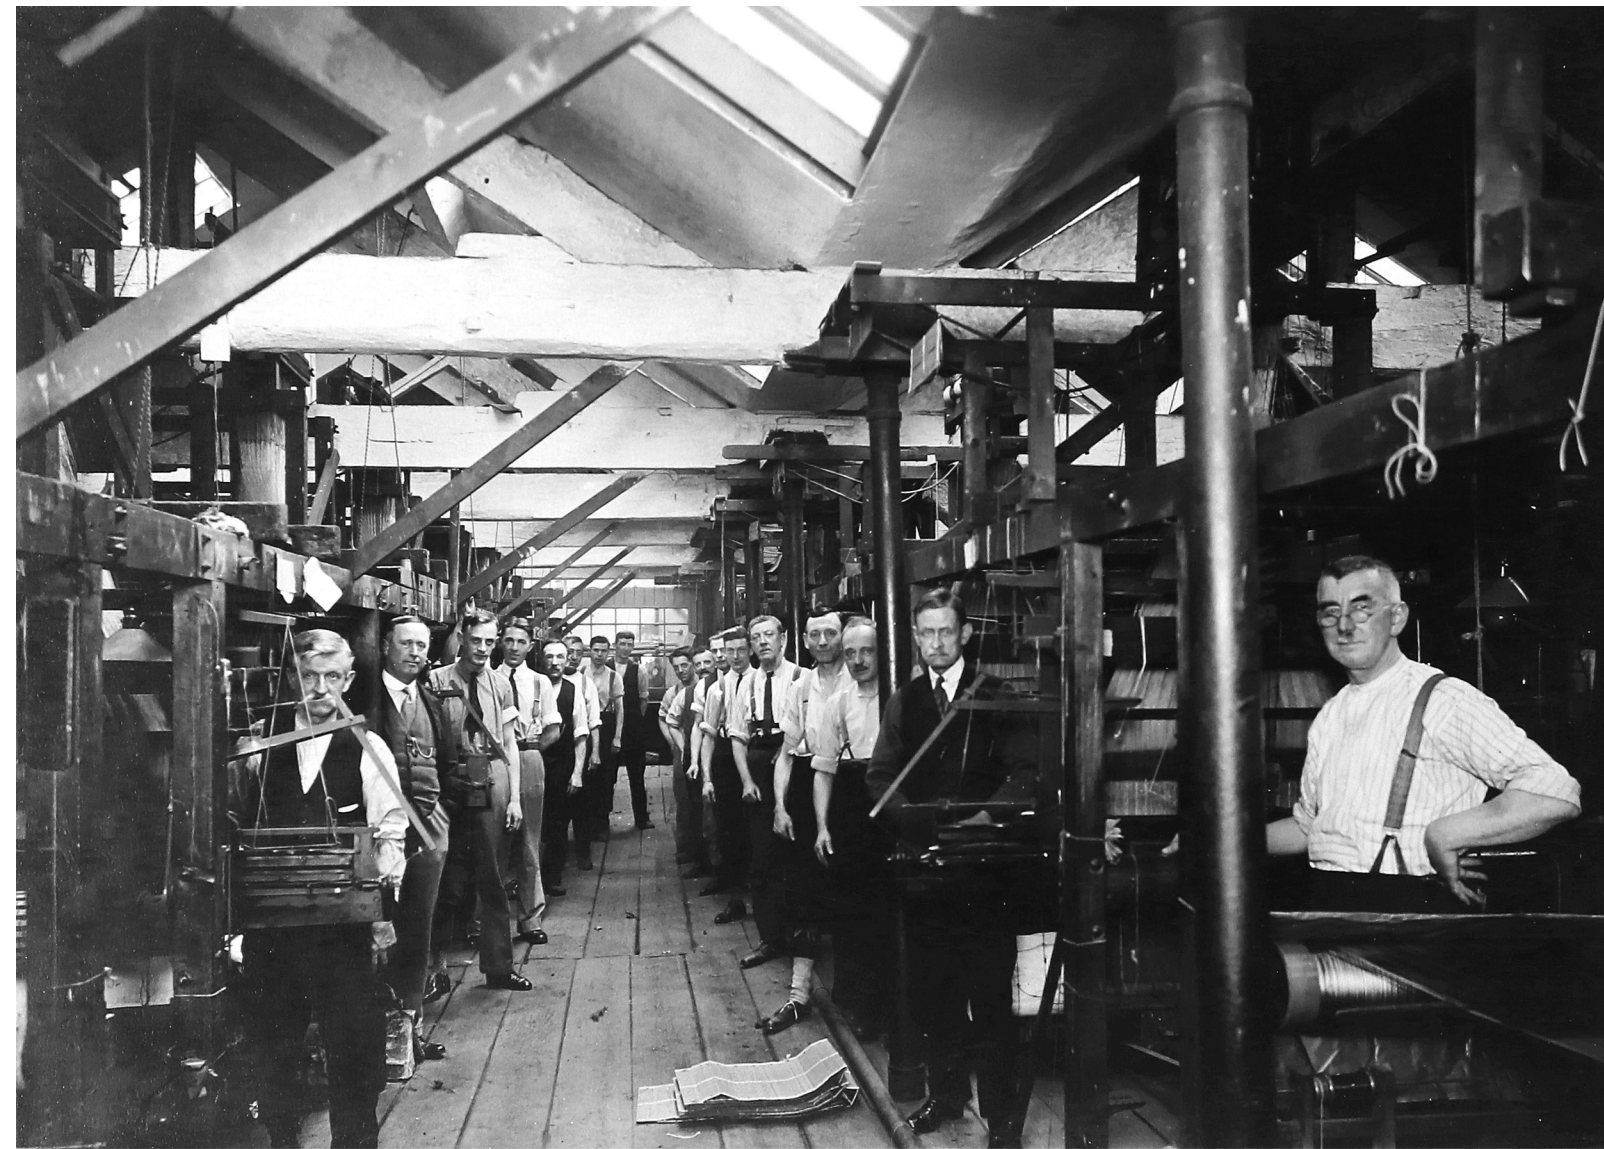
©Macclesfield Silk Museum 1982/332

**“The attic level benefitted from extra natural light filtering through the roof, which improved the working environment for the operators of the 70 looms used in jacquard handweaving. The original roof windows in the Paradise Mill attic were fixed and constructed with lead-lined timber glazing bars.”**

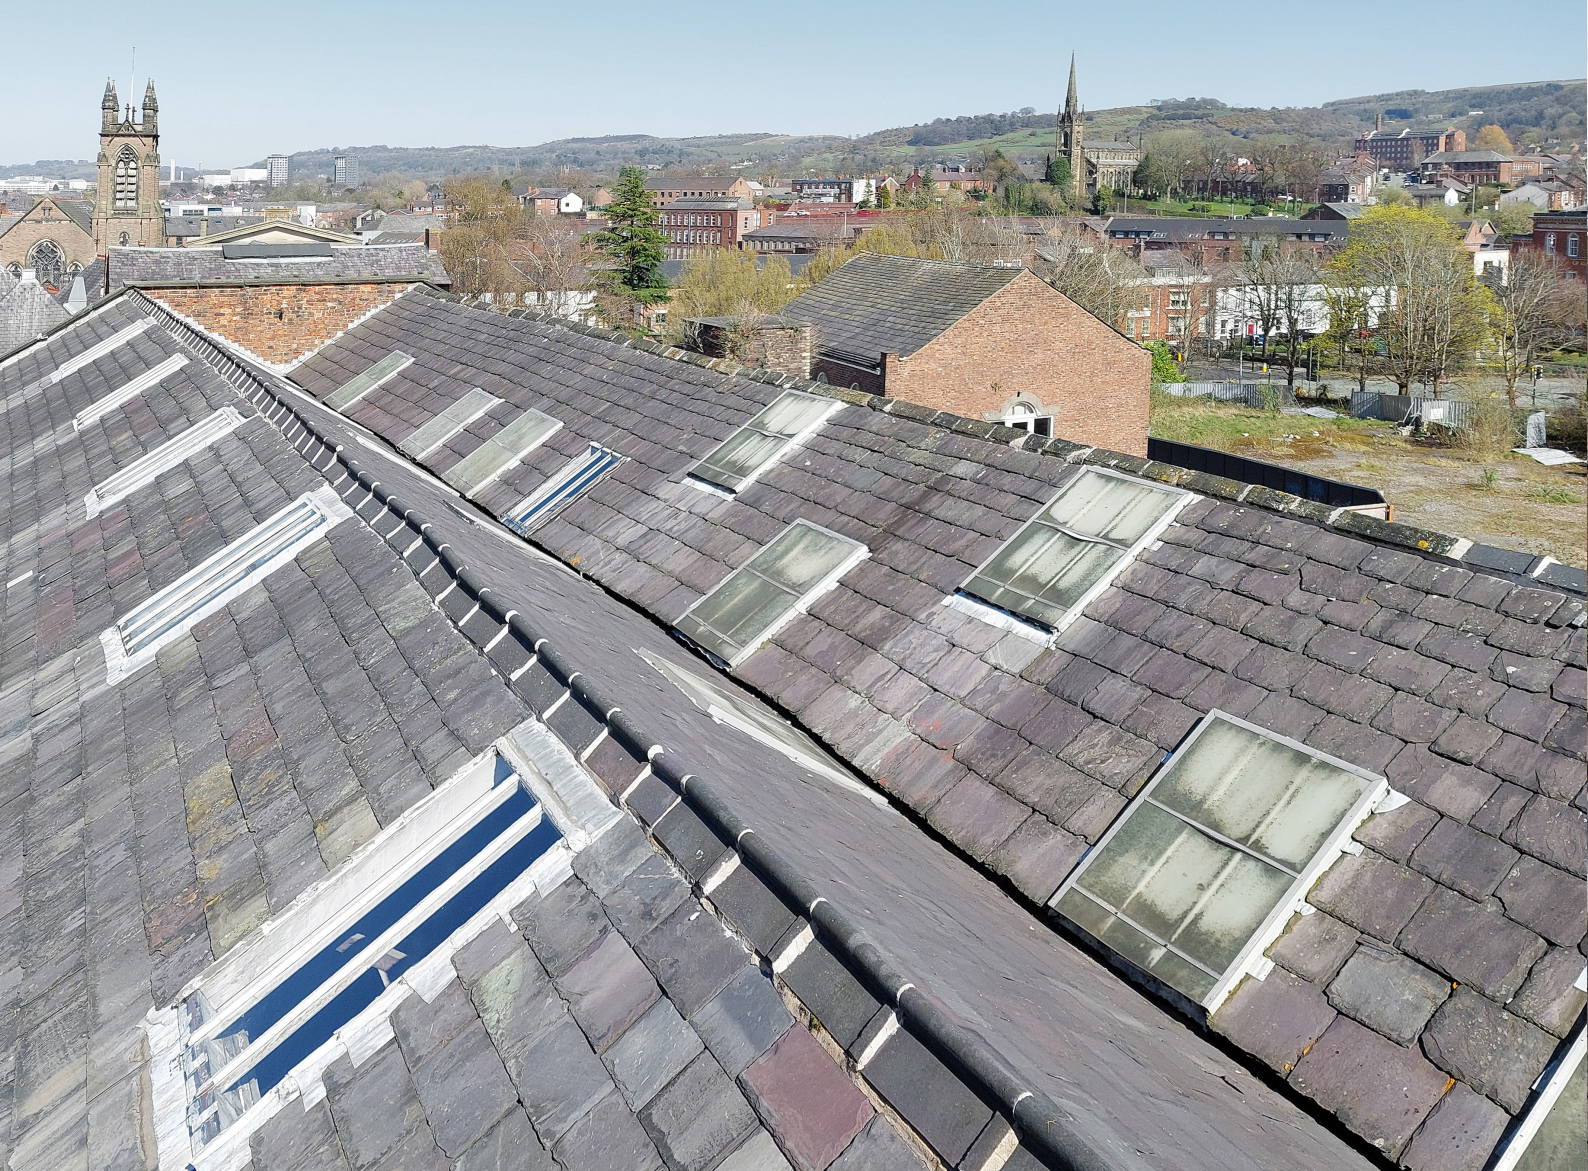
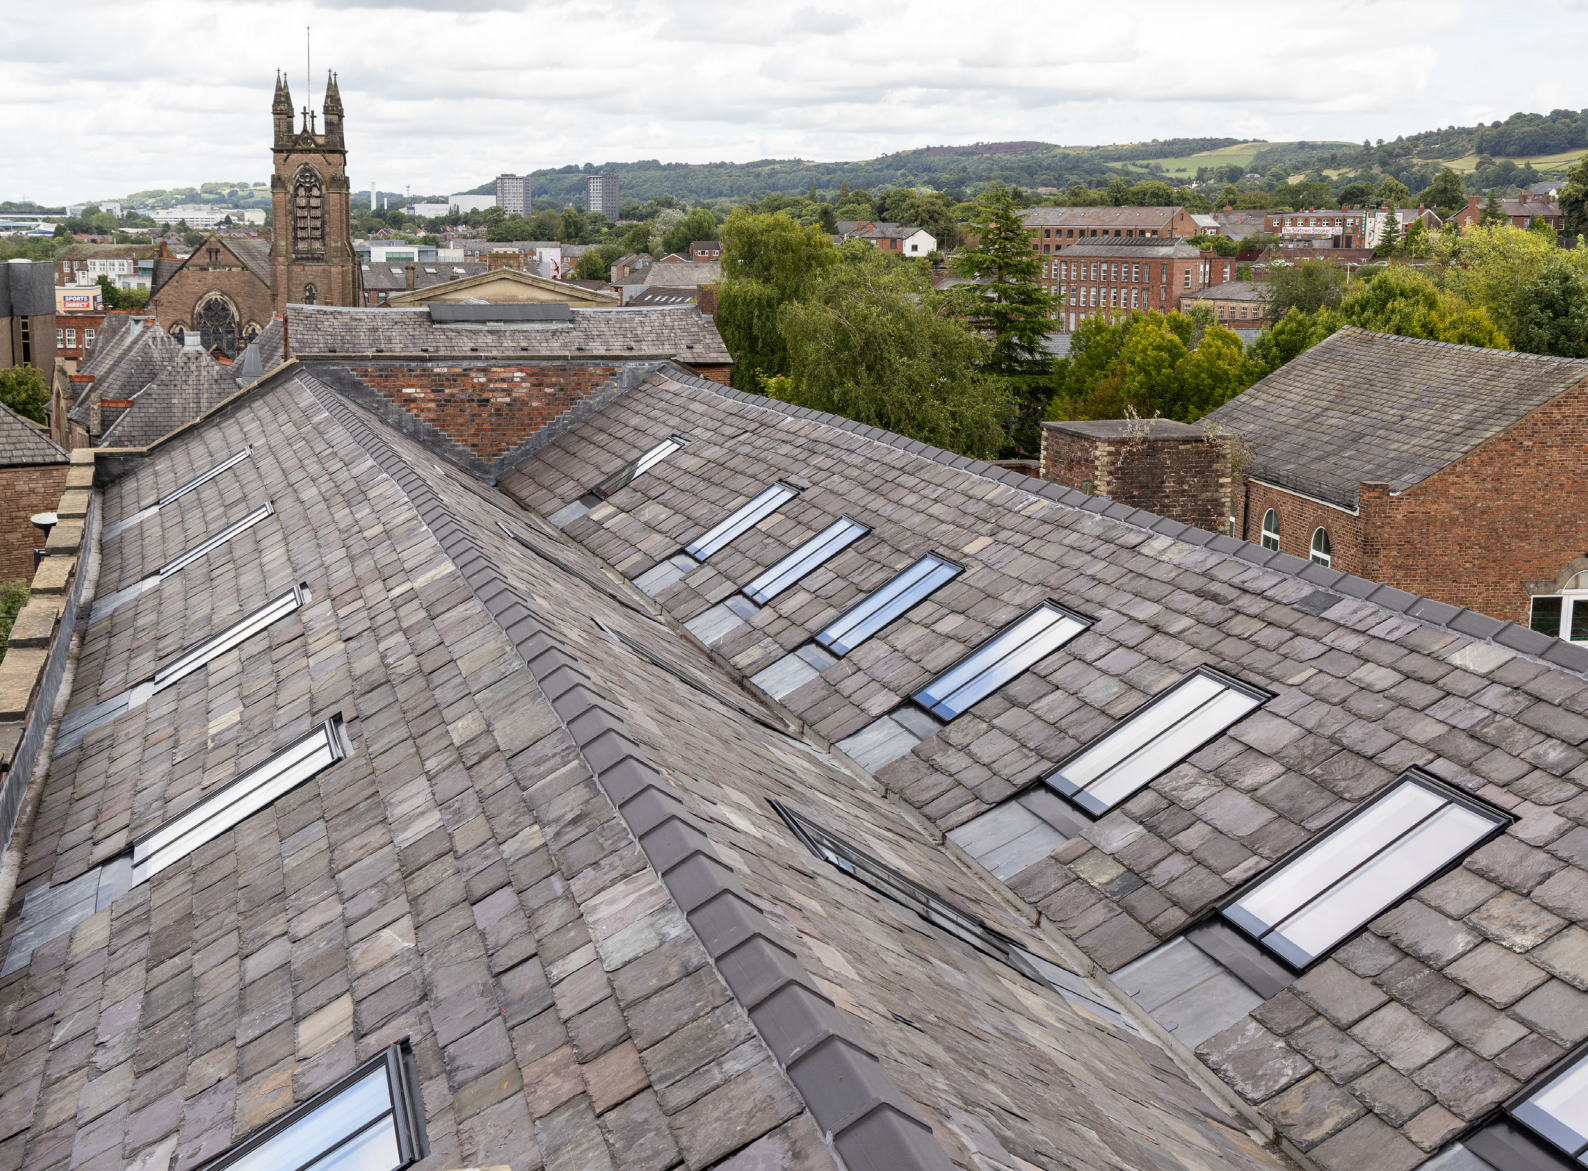
Cross-section through the building. The double-pitched roof was placed symmetrically on the original building, with cast-iron gutter and columns supporting the middle. The extension towards the courtyard was added in the 20th century.

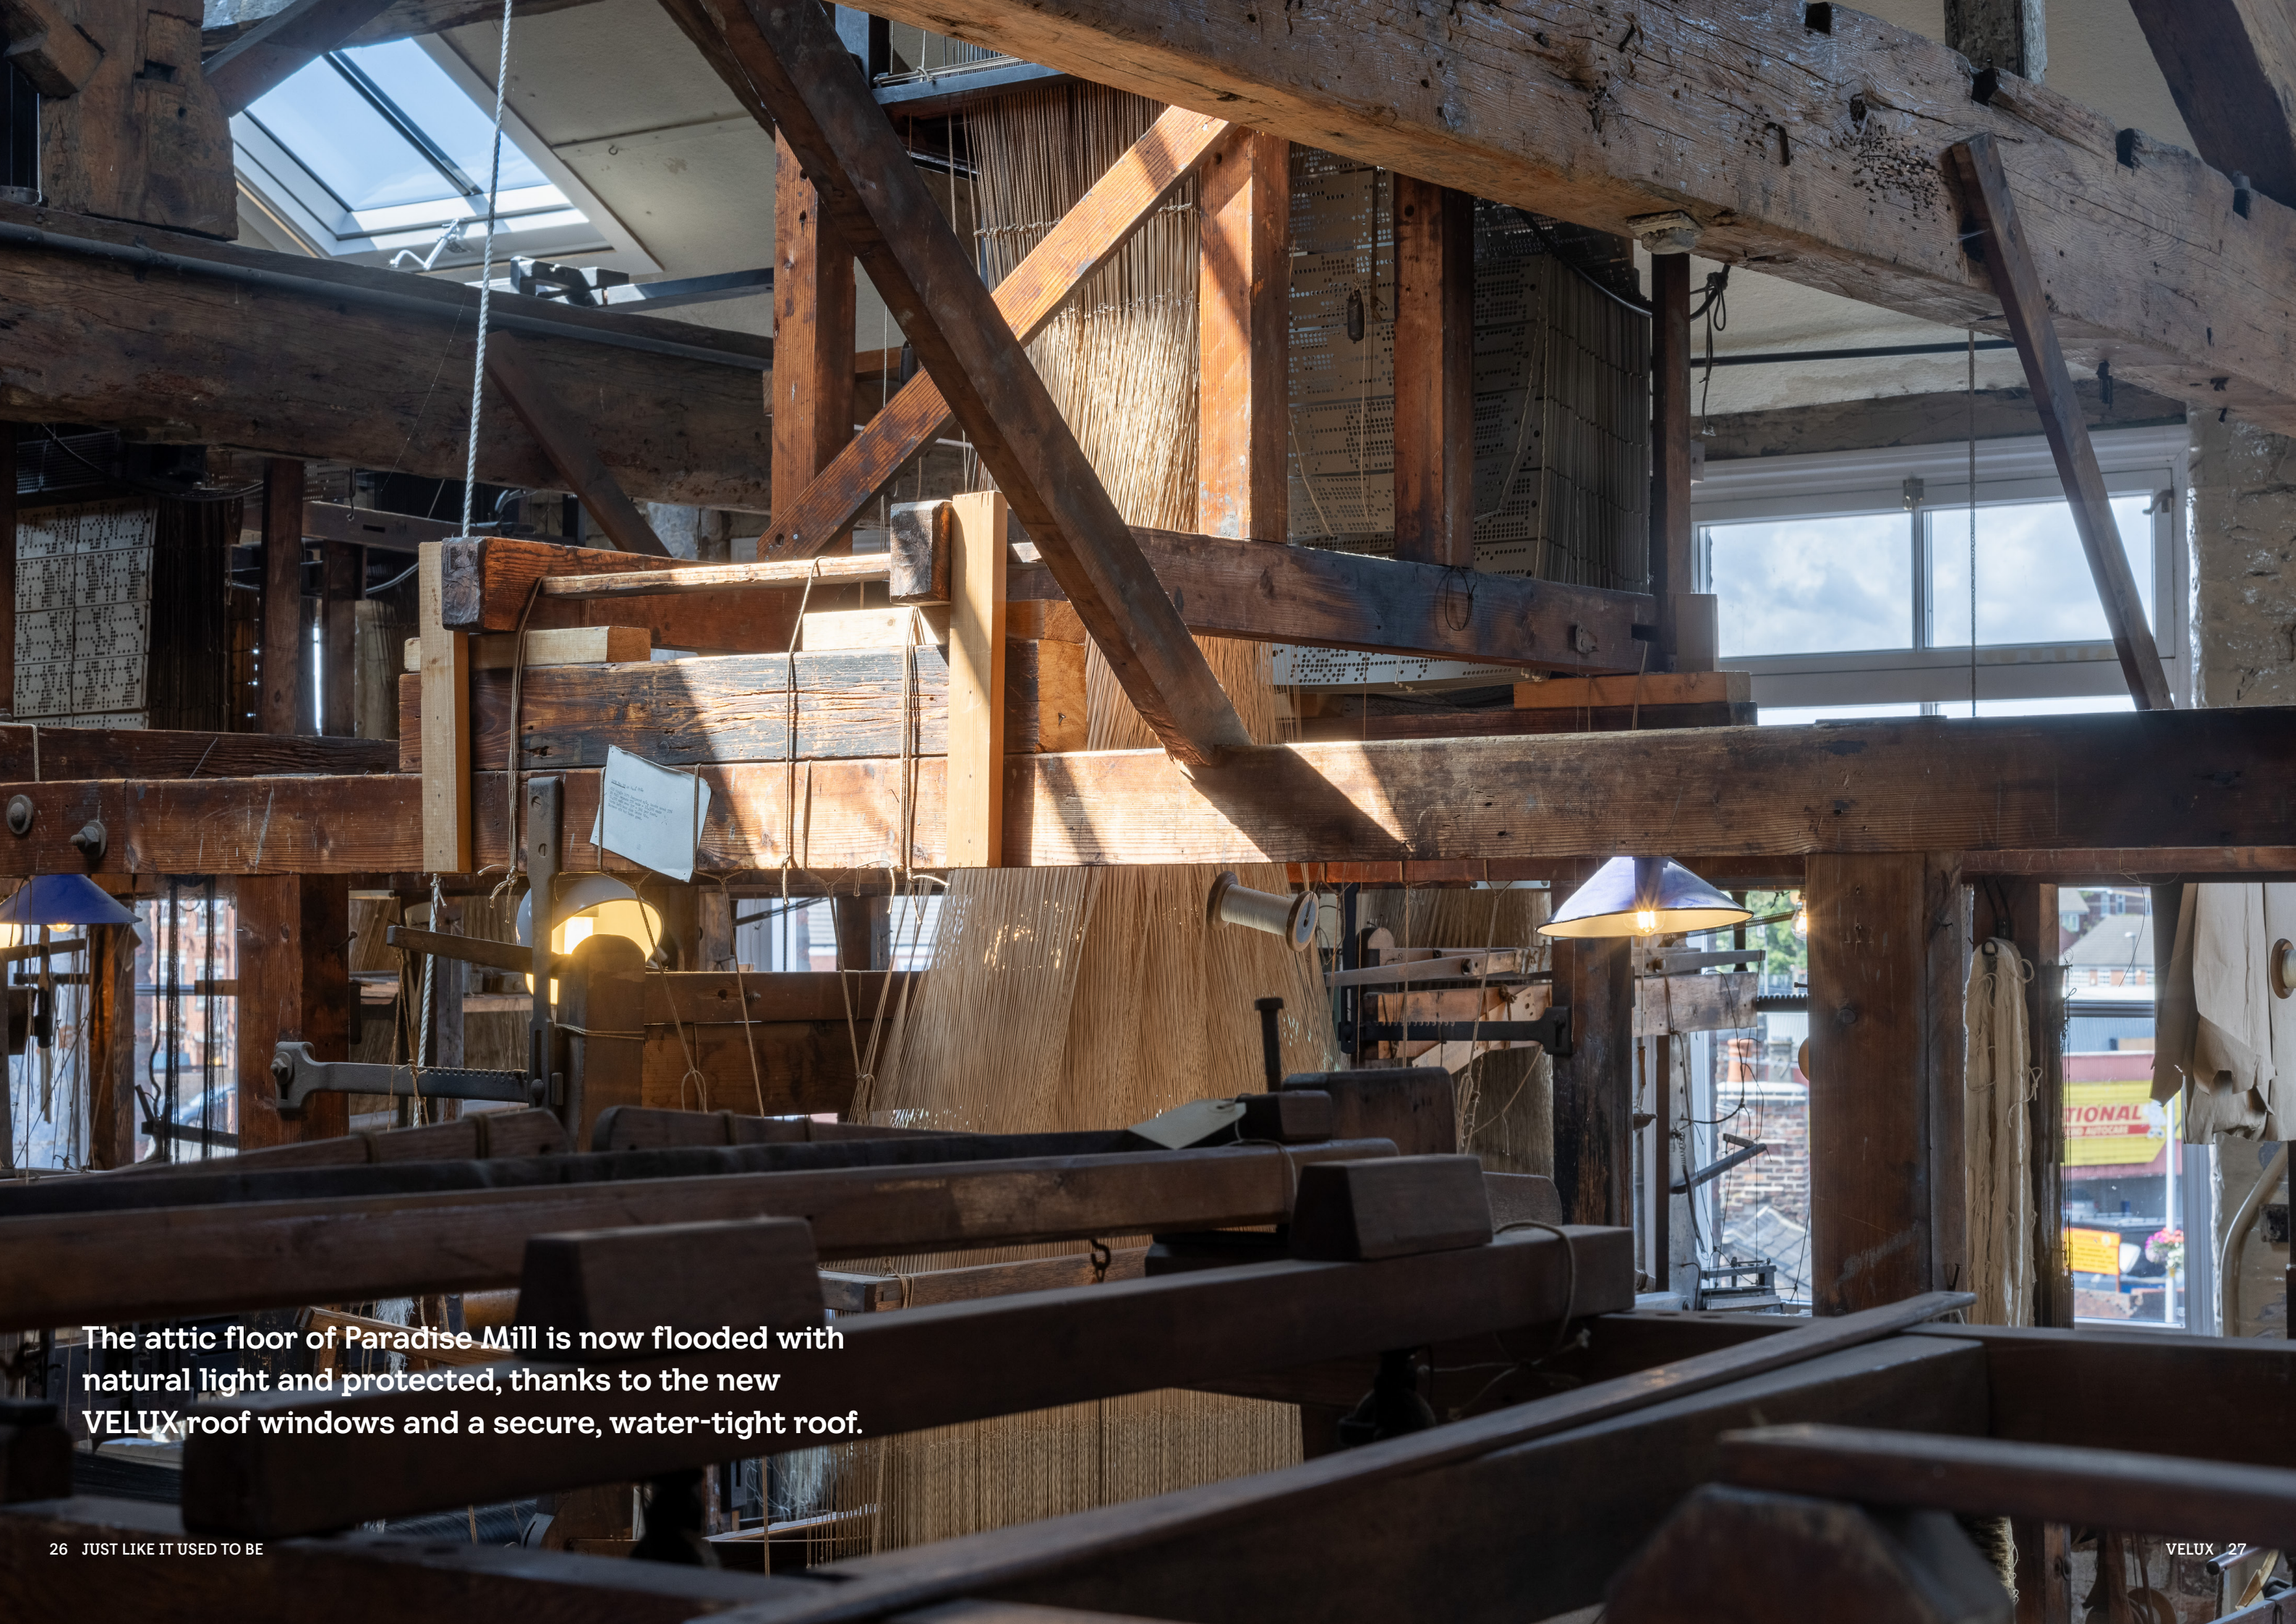
The attic floor of Paradise Mill is now flooded with natural light and protected, thanks to the new VELUX roof windows and a secure, water-tight roof.
